# Manhole Inspection Summary

Manhole # S35GG\_018MH

Insp Date: **4/5/07 12:33 PM**

**Location** Address: **101 MT ROYAL AVE**

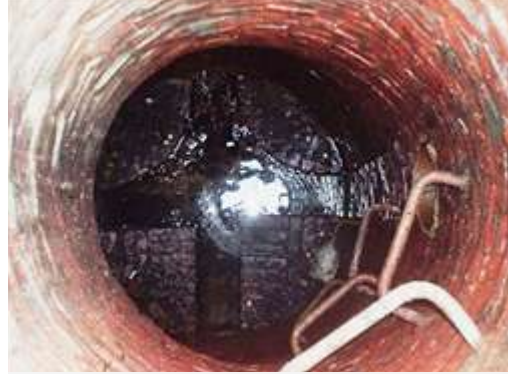
Top View

Corroded steps. Bench and Channel debris.

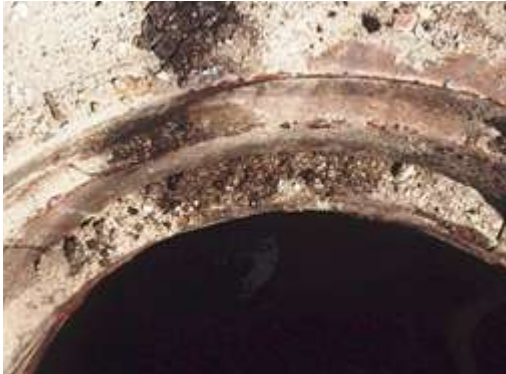
Defect

**Frame** Offset: **3** (in.) Condition: ☒ Sound ☐ Cracked ☐ Leaks

Frame offset.

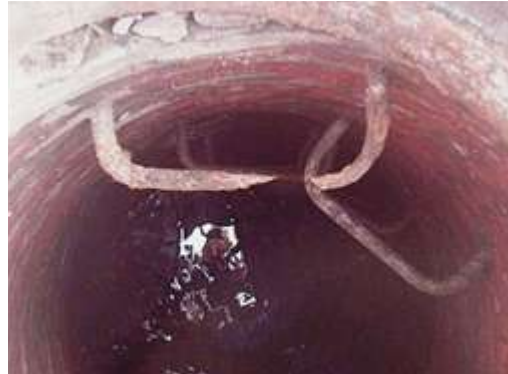
Defect

**Steps** Count: **6** Missing: **1** ☒ **Corroded**

Corroded and missing steps.

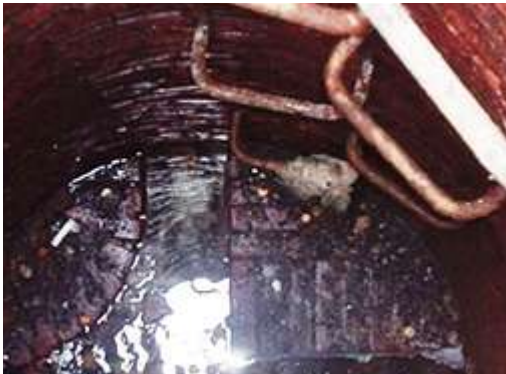
Defect

**Surcharge** ☒ **Evidence Of Surcharge** Depth: **3** (ft.) ☐ Active Surcharge Present

Evidence of surcharge - Bench debris.

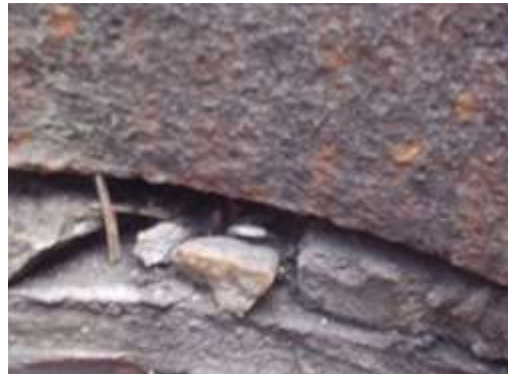
Defect

Condition: ☐ Sound ☐ Cracked ☐ Root Intrusion ☐ Loose Brick ☒ **Deteriorated**

Infiltration: ☐ None ☒ **Joint** ☐ Cracks ☒ **Mortar** ☐ Roots ☐ Wall

Adjustment deterioration, loose brick and infiltration

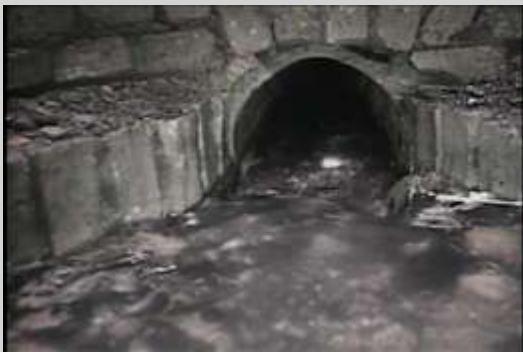
### 8 in. Circular Gravity Sewer Pipe Out @ 12 O'Clock

Deposits: ☐ None ☒ **Mud** ☐ Sludge ☒ **Debris** ☐ Grease

Silt Depth: **1** (in.) Deposits Extent: **Light**

Infiltration: **None** Pipe Seal Cond: **Broken**

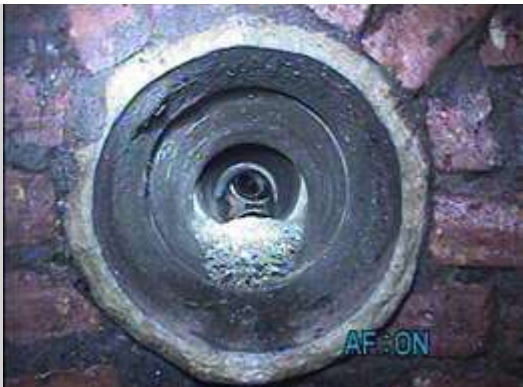
### 8 in. Circular Gravity Sewer Pipe In @ 3 O'Clock

Deposits: ☐ None ☒ **Mud** ☐ Sludge ☒ **Debris** ☐ Grease

Silt Depth: **1** (in.) Deposits Extent: **Light**

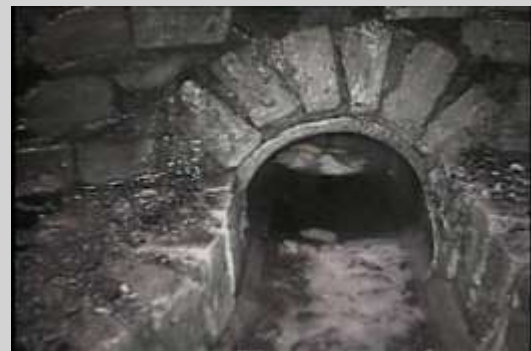
### Drop In @ 3 O'Clock

Condition: ☐ Sound ☐ Cracked ☐ Root Intrusion ☐ Loose Brick ☒ **Deteriorated**

Infiltration: ☐ None ☐ Joint ☐ Cracks ☒ **Mortar** ☐ Roots ☒ **Wall**

Barrel deterioration and infiltration.

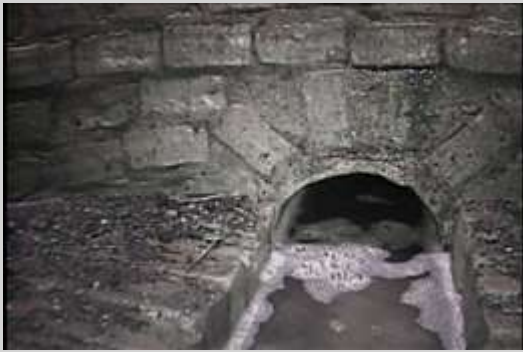
Pipe In @ 6 O'Clock

Infiltration: **None** Pipe Seal Cond: **Broken**
